Sustainable Historic Architecture in Rural Areas – Concept for a sustainable and low carbon retrofit of a Bavarian farmhouse

Frankonian Homestead "H14"

Project "H14" (North Baveria Germany) Franconian homestead (1868)

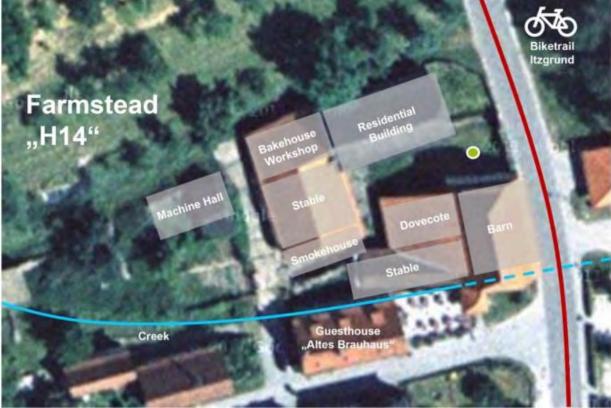
Image 2: Status quo "H14" (prior to the planning)

and the entrance area is furnished with terrazzo flooring, the initially laid sandstone tiles in the former stable were replaced by a concrete floor. Unlike the well preserved ground floor, the upper and attic floor were in a poor condition and in danger of collapsing. Due to penetrating humidity numerous wooden beams in the roof and the walls were destroyed and suffered severe damage.

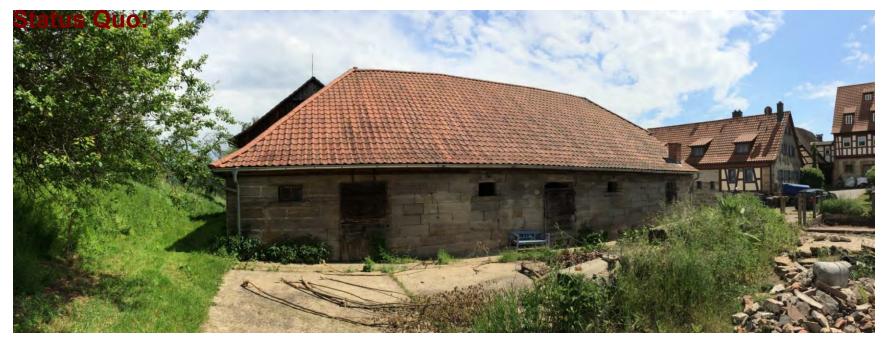
H14 (Ansicht West): nicht unterkellert, zum Teil Versalzung der Wände (ehemalige Stallnutzung)

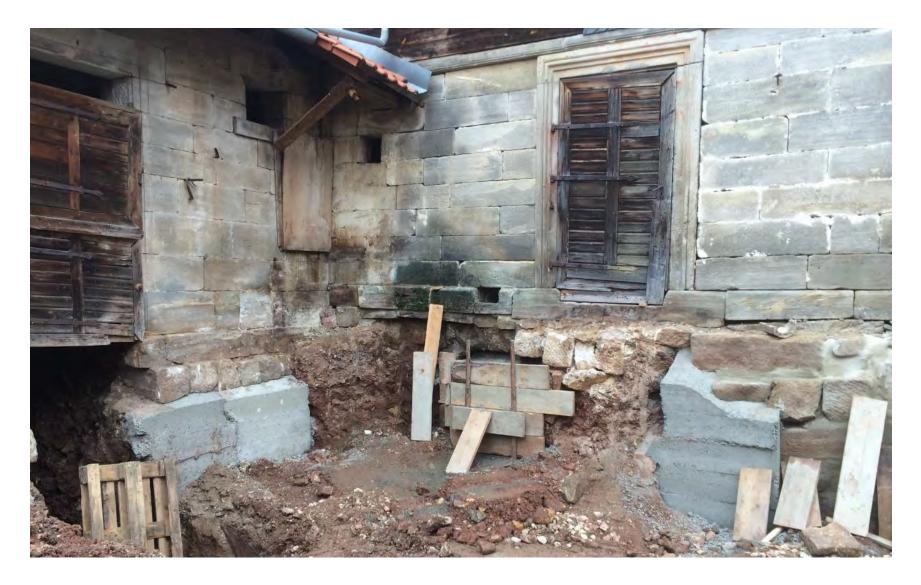
Major damages of the foundation

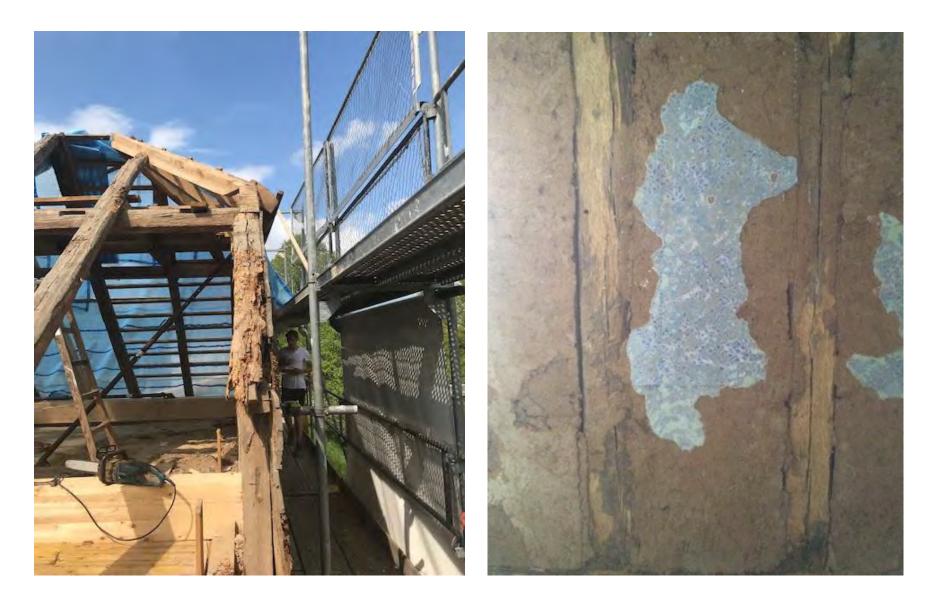
Major damages of the roof structure

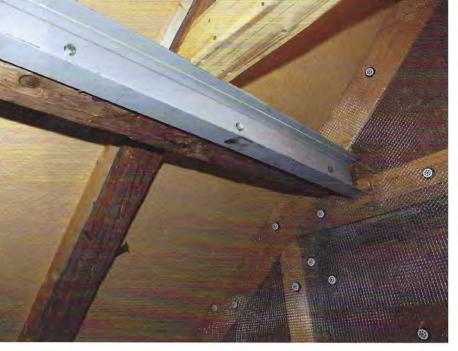
< Die Tragkonstruktion musste umfassend erneuert und verstärkt werden

Kräftige Überzüge und Stahlträger ergänzen das statische System dass zahlreiche Sparren erneuert oder durch Aufblatten verstärkt werden mussten. Der gesamte Stuhl wurde von den Zimmerern nach Statik mit Stahlträgern verstärkt. In großen Bereichen wurden die Fußpunkte des Kehlbalkendaches sowie die Zerrbalkenköpfe ersetzt oder ergänzt. Auch die Kehlbalken mussten erneuert und verstärkt werden. Zudem mussten weitere statische Maßnahmen ergriffen werden, die mit Überzügen aus kräftigen Konstruktionsvollholz-Trägern die Struktur ergänzen.
