Sustainable Historic Architecture in Rural Areas – Concept for a sustainable and low carbon retrofit of a Bavarian farmhouse

Frankonian Homestead "H14"

Project "H14" (North Baveria Germany) Franconian homestead (1868)

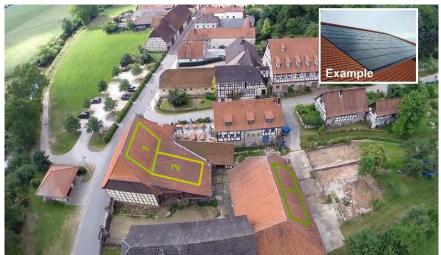
Image 5: Photovoltaic concept in cooperation with the monument protection authority

water heat pump for the base load and the use of multiple wood-burning stoves (partially water bearing). The operation of the air-water heat pump is supported by the electricity generated by a photovoltaic plant, which is hidden and integrated in the roof of the former dove cote (annex of the barn). The concept of the installation of the PV system was coordinated with the office for the preservation of monuments beforehand (see Image 5). In the future, battery storages and e-mobility are to be integrated.

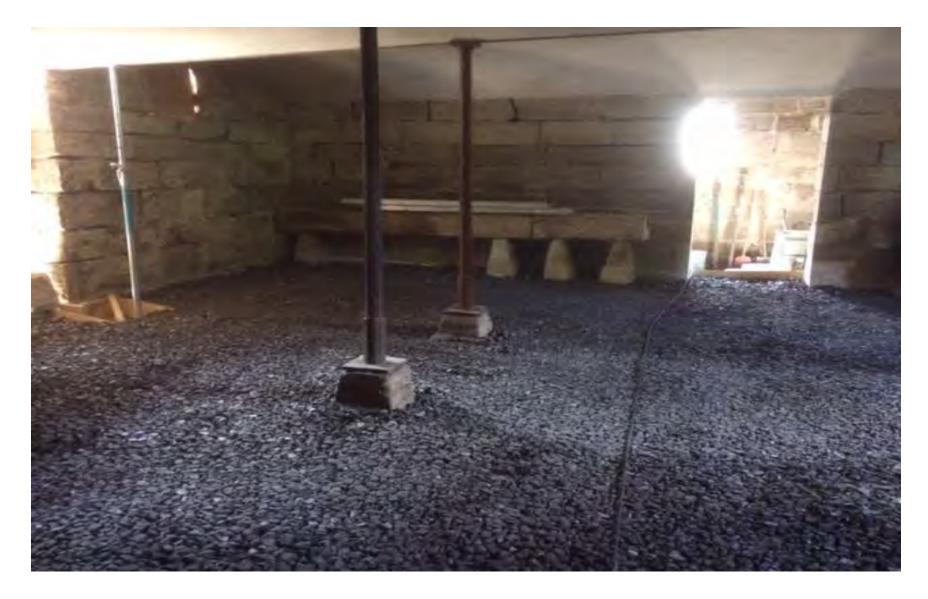
Foam glass insulation (seminar rooms)

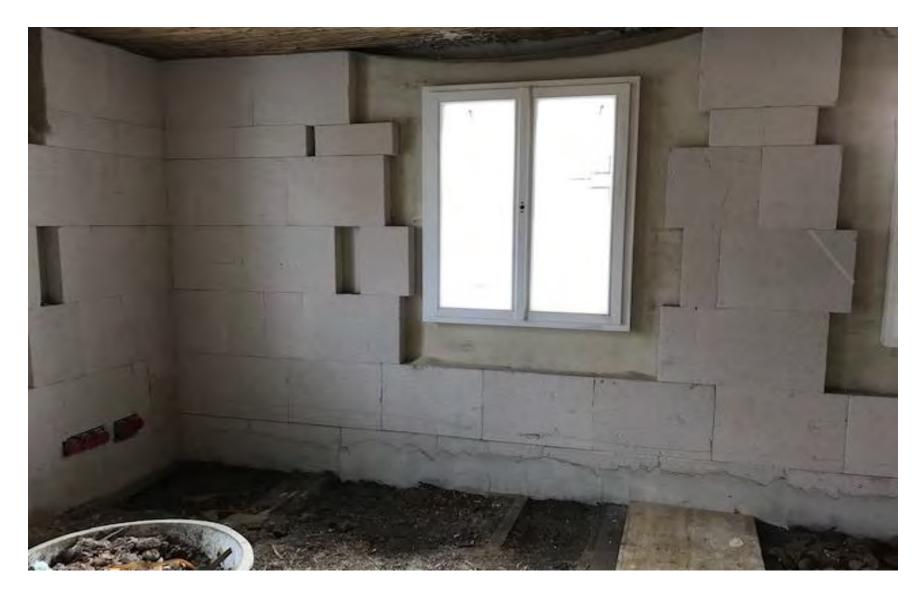
Mineral foam insulation (living roams)

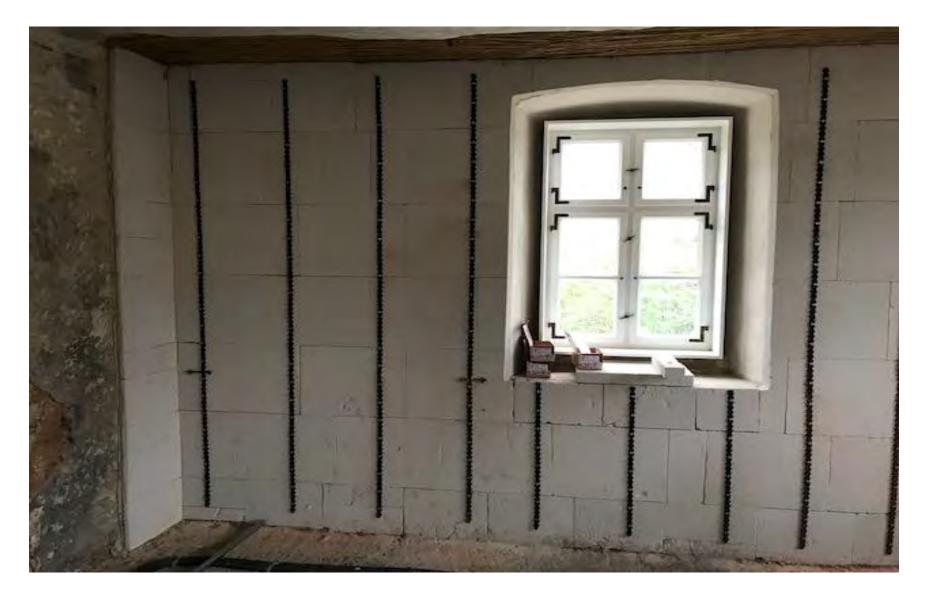
Mineral foam insulation (living roams) and holders for wall heating pipes

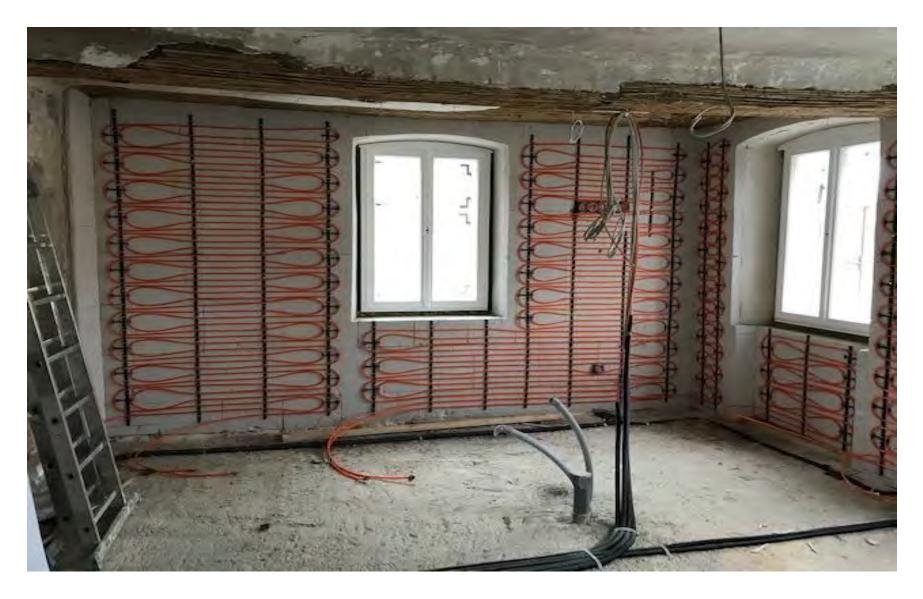
Mineral foam insulation (living roams) and wall heating pipes

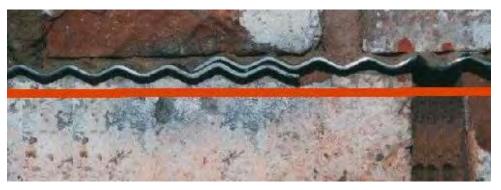
Horizontalsperre durch Einschneiden?

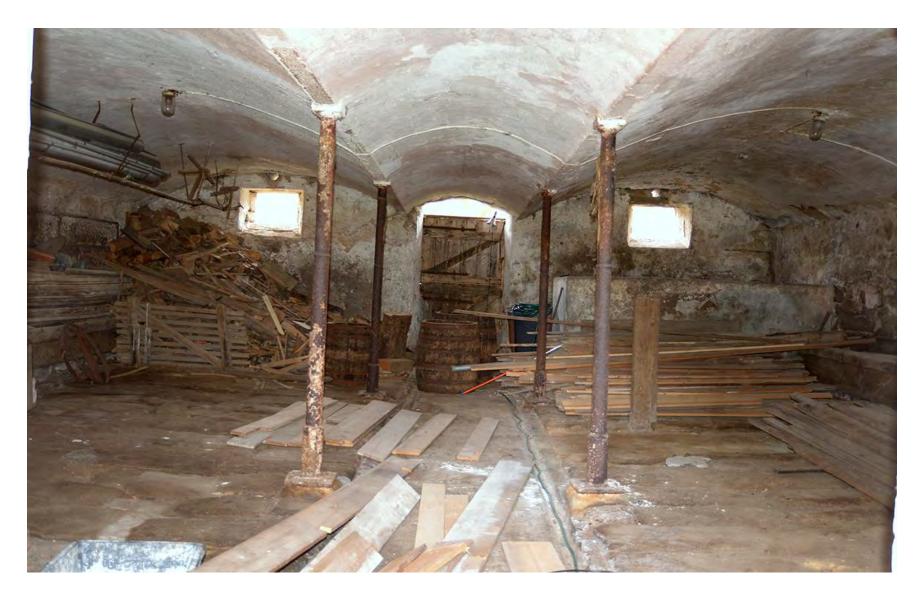
Seminar rooms before renovation

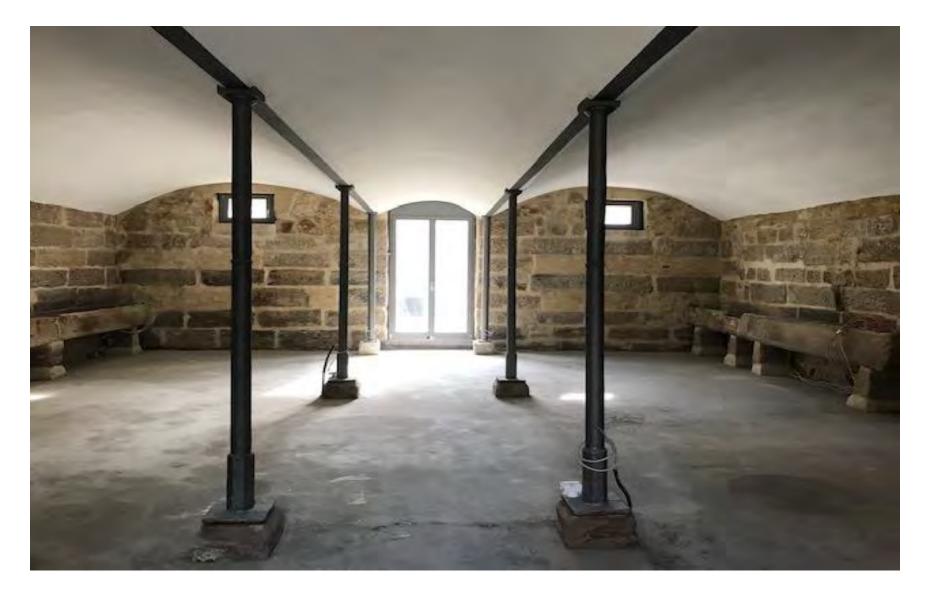
Seminar rooms during renovation

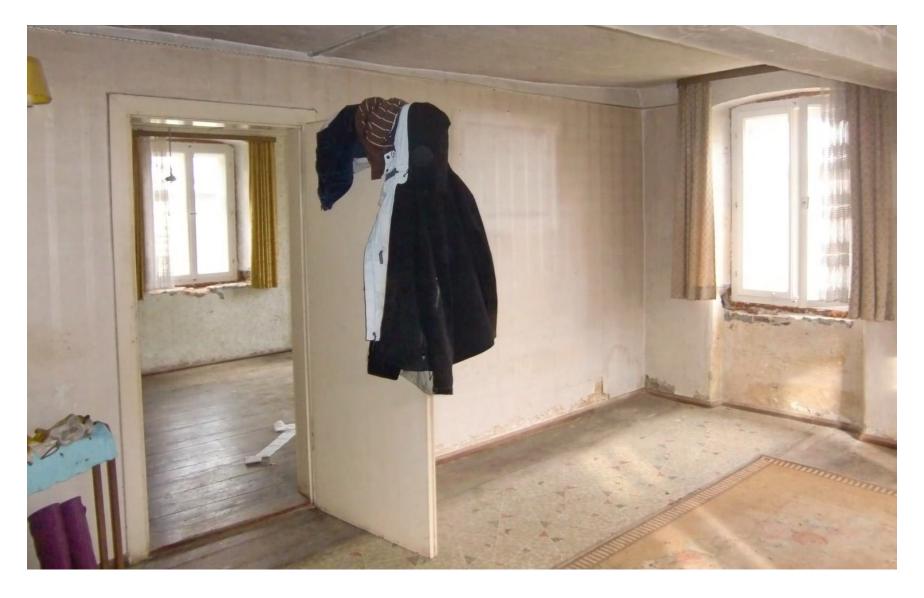
Kitchen before renovation

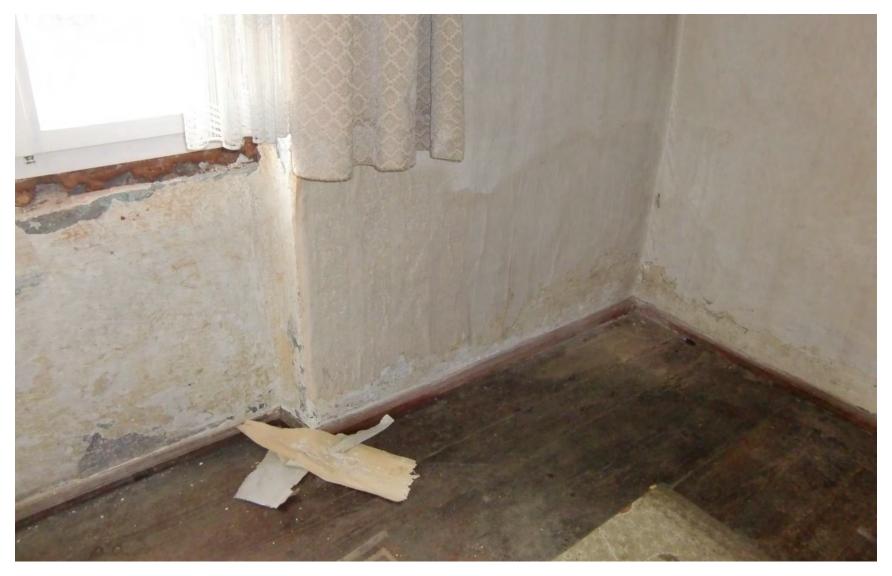
Kitchen before renovation

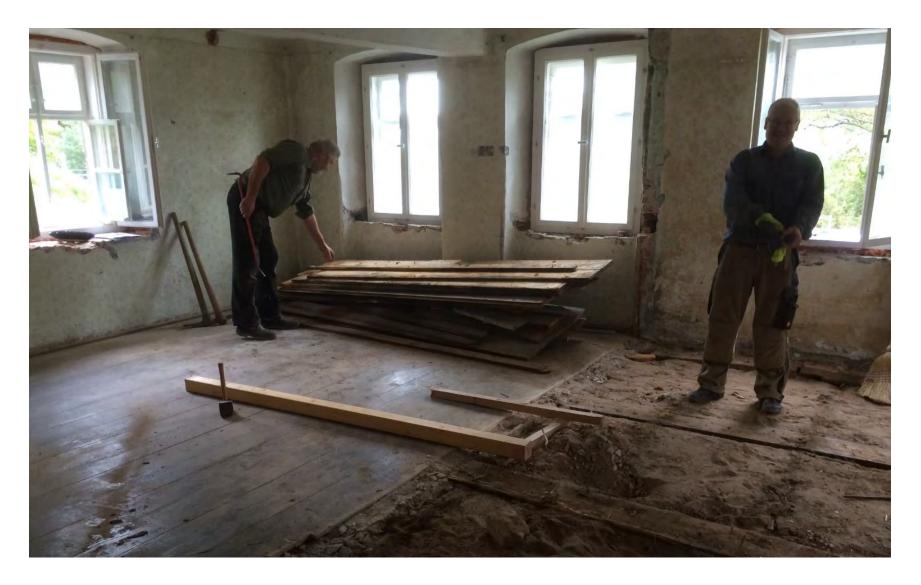
Kitchen during renovation

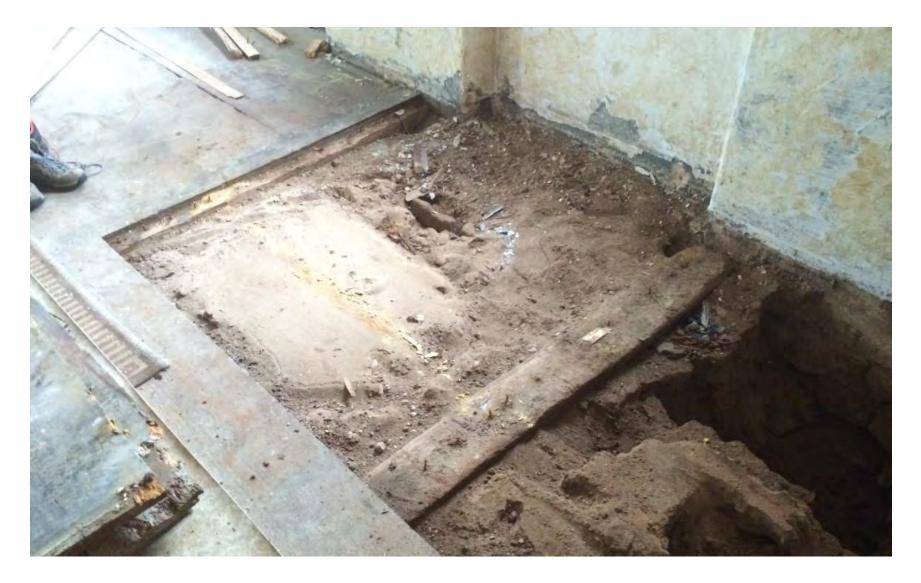
Kitchen during renovation

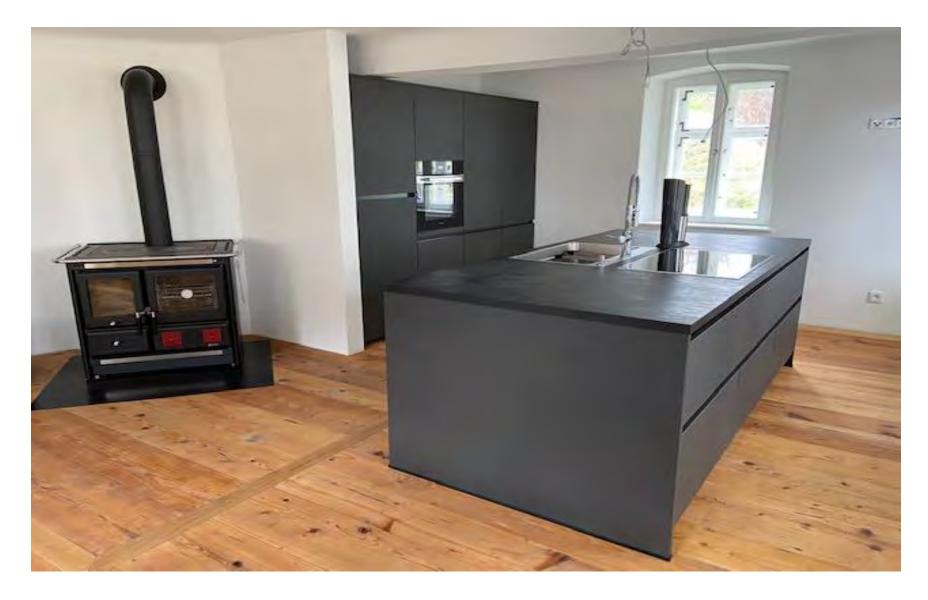
Kitchen after renovation

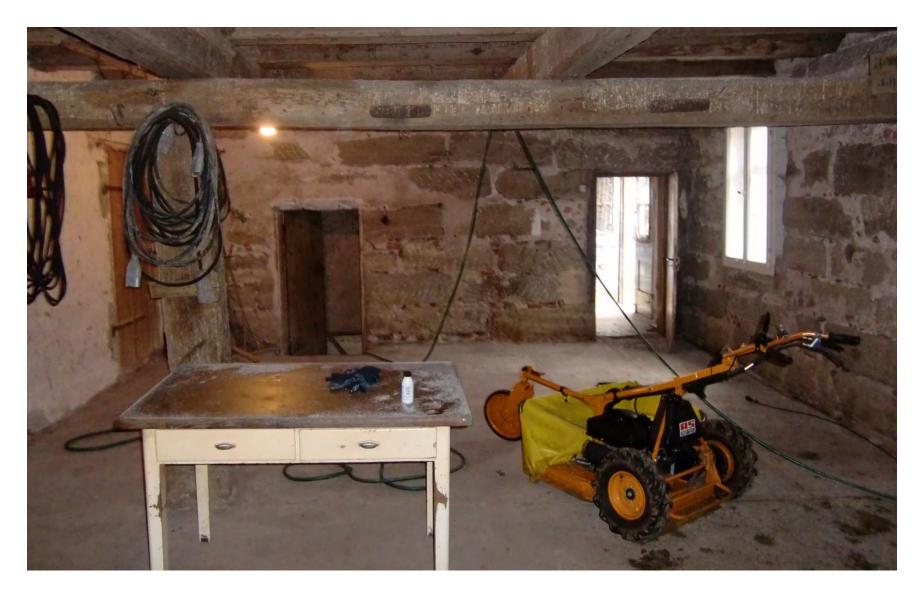
Living room before renovation

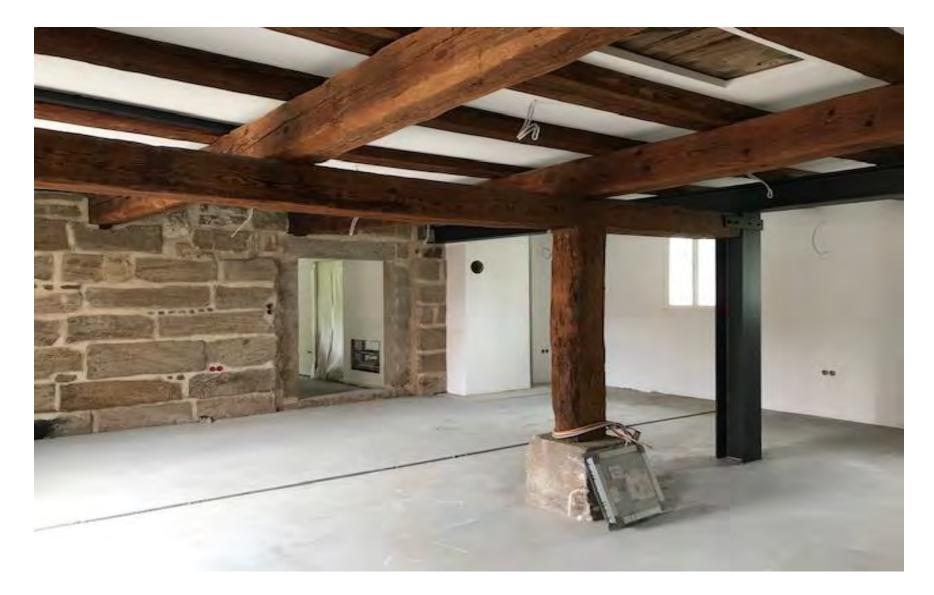
Living room during renovation

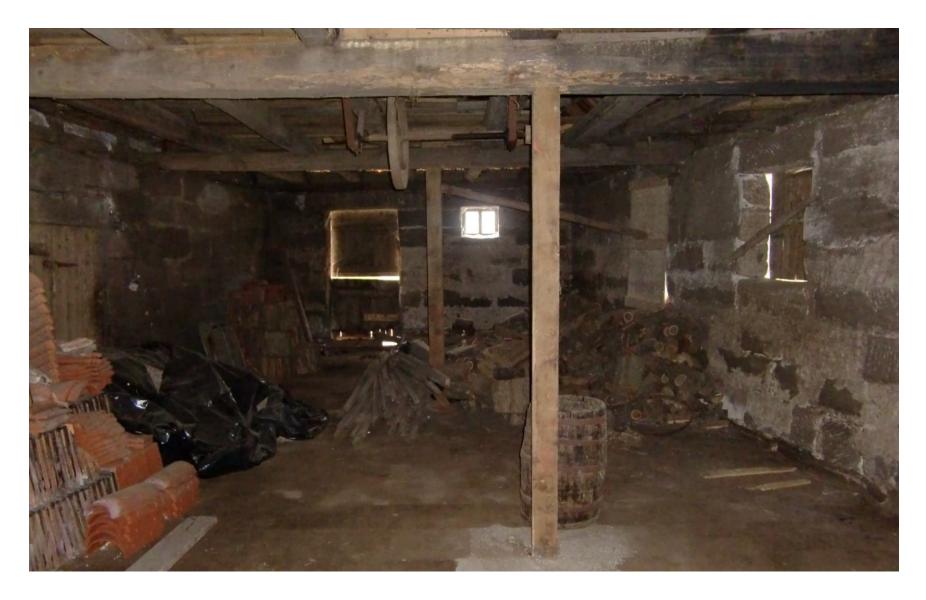
Office rooms before renovation

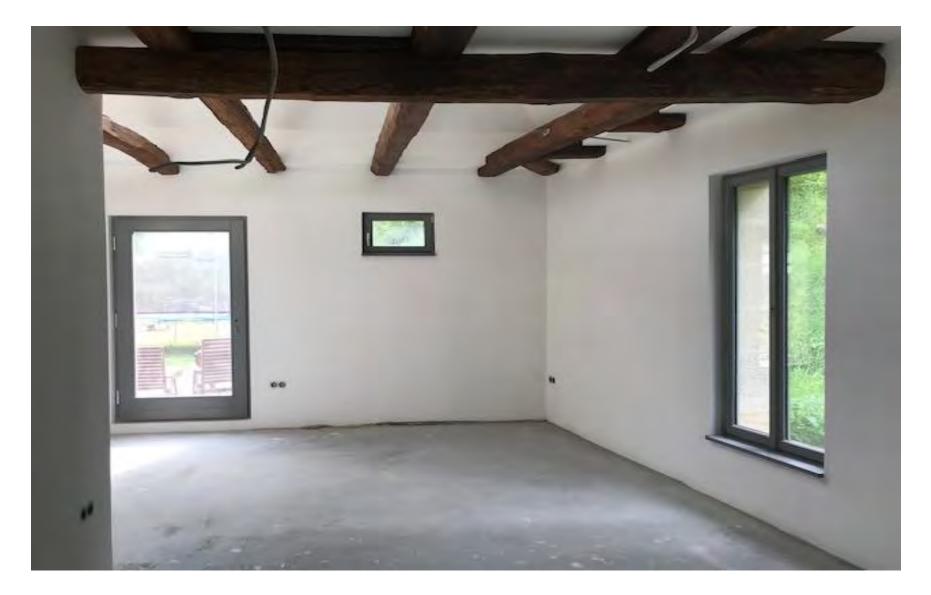
Office rooms during renovation

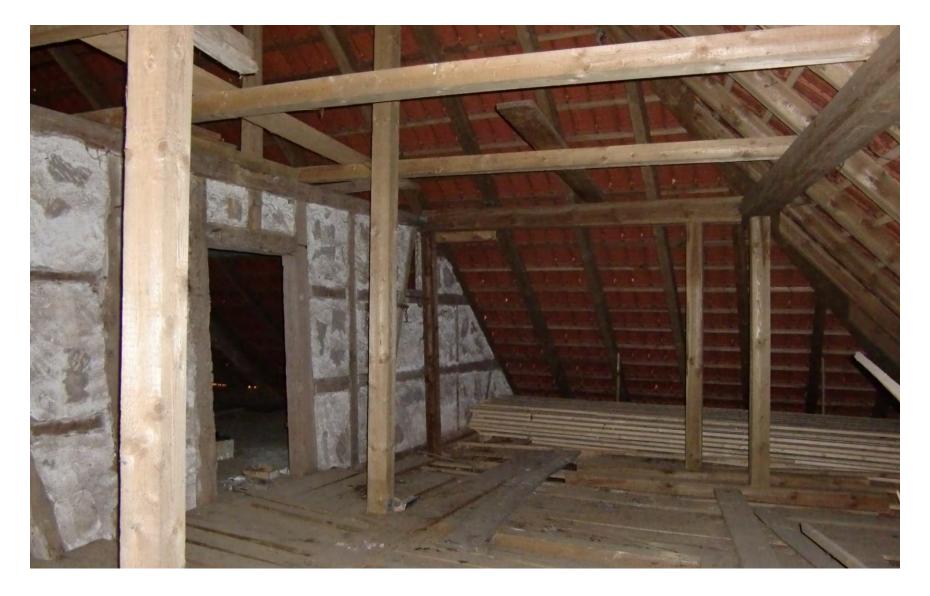
Office rooms before renovation

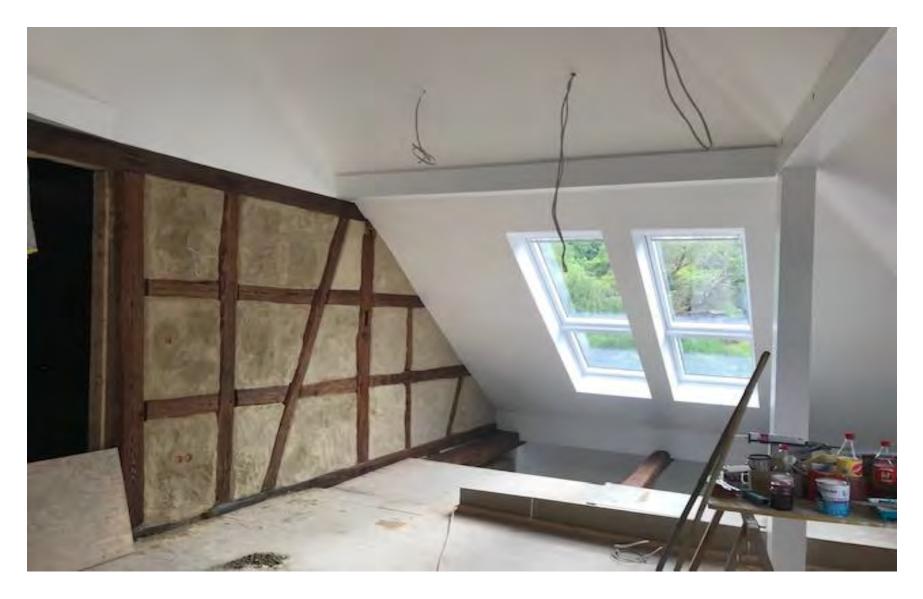
Office rooms during renovation
